G1000[™]

*annunciations and alerts
pilot's guide for Cessna Nav III*

9.1 INTRODUCTION

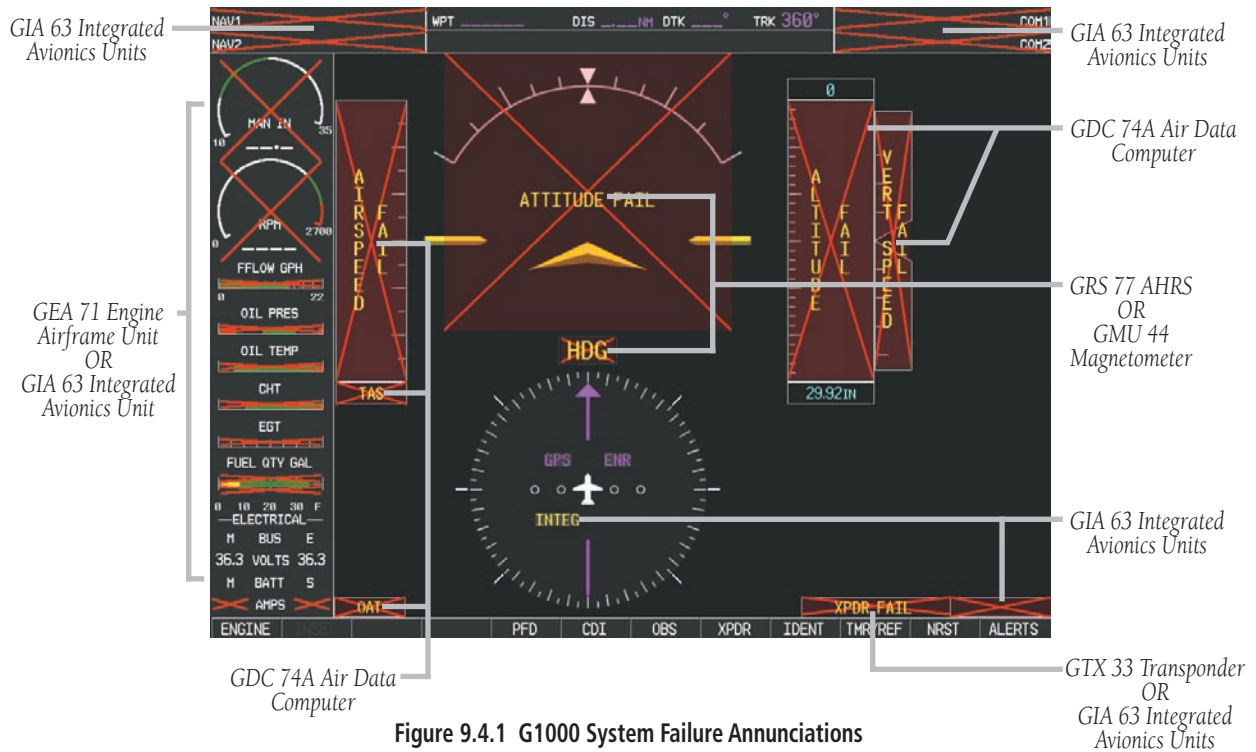
<p>Display system is not receiving valid transponder information.</p>
<p>Other Various Red X Indications</p>	<p>A red 'X' through any other display field (such as the engine instrumentation fields) indicates that the field is not receiving valid data.</p>

A red 'X' may be the result of an LRU or an LRU function failure. The figure presented below illustrates all possible flags and the responsible LRUs.

When an LRU or an LRU function fails, a large red 'X' is typically displayed on windows associated with the failed data. The following section describes various system annunciations. Refer to the Aircraft Flight Manual for additional information regarding pilot responses to these annunciations.

This section describes various G1000 system message advisories. Certain messages are issued due to an LRU or an LRU function failure. Such messages are normally accompanied by a corresponding red 'X' annunciation as shown previously in the G1000 System Annunciation section.
